An Unusual Death in the Workplace: A Case Report

Türkiye Klinikleri J Foren Med 2007, 4:81-85

Case Report

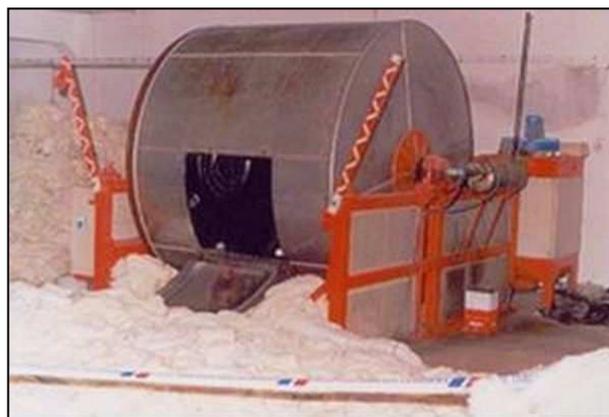
The softening drum has a diameter of 190 cm, making 8 cycles per minute, cycling in both direc-

tions (forward and backwards), having two arms outside should both be pressed and closed down in order to work the drum (Figure 4). The door of the drum can only be opened and closed outside. There are a total of 11 metallic projecting parts, each with a height of 26 cm high and a diameter of 4.5 cm (Figure 5). In order to make the drum work, a control switch should be turned on by rotating suggesting that it cannot be switched on just by throwing some materials on it. Therefore, we concluded that it cannot be an accident in the manner it was suggested.

Figure 4. The softening drum (opened).

team. Any missing link and data herein makes obscure further decision making process. For example in this case, there was no state about fingerprint taken from the crime scene in the crime scene investigation report. Also, any material was not taken from the crime scene to detect of DNA. We concluded that it cannot be an accident because the machine could not run when the drum's door was open. We are not informed of the decision of the judge of this case.

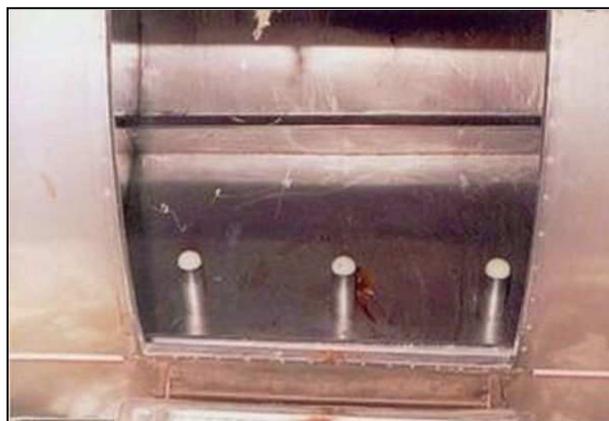
Figure 5. The interior of the softening drum (through the lid).
